## Failure mechanisms in ceramic capacitors

Multilayer ceramic capacitors (MLCs) have become one of the most widely used components in the manufacture of surface mount assemblies, and are inherently very reliable. However, all ceramics are brittle, and when layout design and manufacturing methods do not take this into account, these normally trustworthy devices can fail unexpectedly, either immediately or (arguably much more seriously) during service.

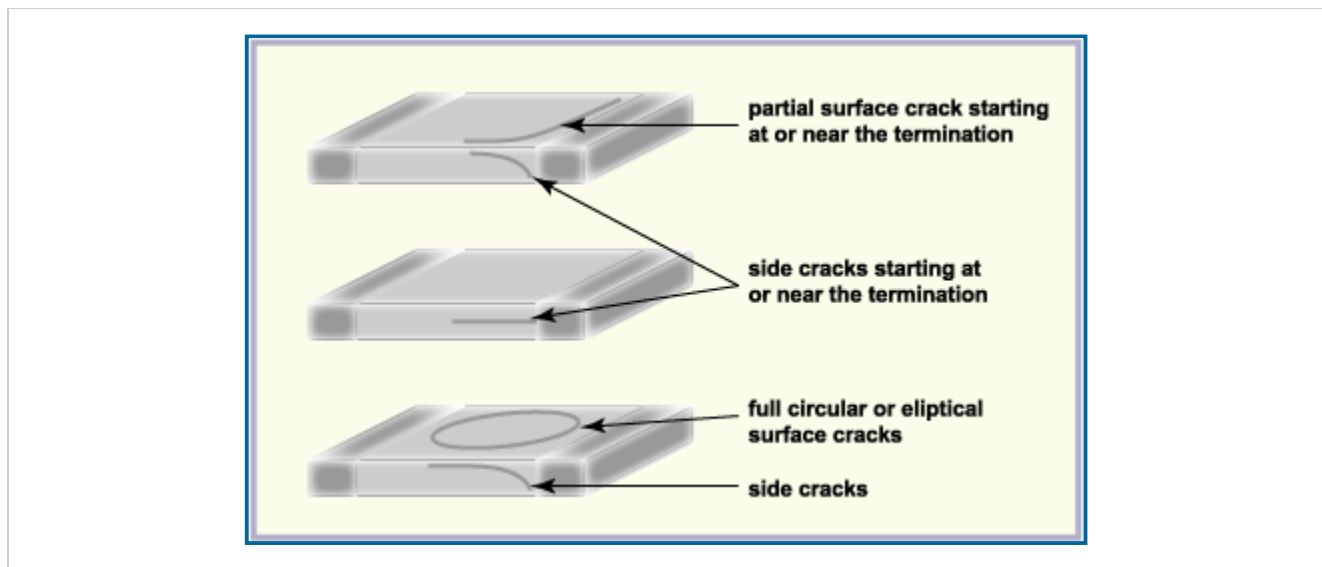
**Figure 1: Extreme thermal shock cracks in MLCs**

The solder terminations also expand at a greater rate (25–30 ppm/°C) than the ceramic part and exert an annular tensile force on the edges of the component. In severe cases, when a large surface mounted capacitor has been subjected to a sudden thermal shock, a clearly visible elliptical crack may form on the upper surface of the chip (Figure 1). This is primarily due to the tensile forces exerted by the terminations.

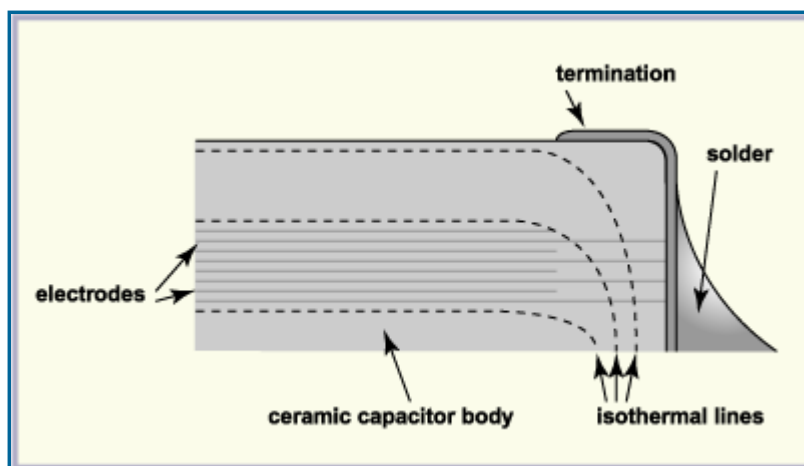
**Figure 2: Micro-cracking under thermal stress**

Less obvious is the creation of micro-cracks under the visible surface of the capacitor, which propagate along isothermal lines within the component (Figure 2). This form of damage is particularly insidious, since electrical failure may not occur until some time after assembly, when the finished product is out in the field.

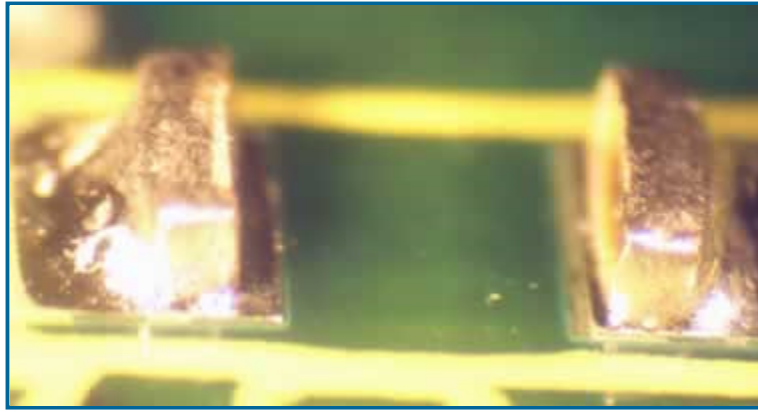
#### Capacitor missing after severe cracking

After a number of temperature excursions, for example due to circuit operation, the crack may propagate (Figure 3), creating an open-circuit device. In severe cases, the body of the capacitor may even fall out, leaving just remnants of ceramic surrounded by termination and solder joints.

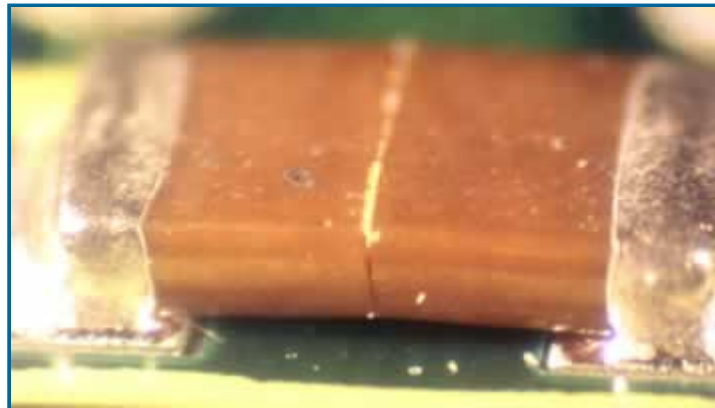
### Cracked capacitor

When a circuit board is bent, its shape tries to become an arc of a circle, as far as the rigidity of the attached components will allow. The outer surface stretches and the distance between the component lands is increased, placing the chip under tension: conversely, on the inner surface, an MLC is exposed to compressive strain. Whilst any joint will stress-relieve, given time, in the short term only a limited degree of stress reduction can come from deformation of the solder joint. If the forces applied to the chip exceed its breaking strength, the chip will crack!

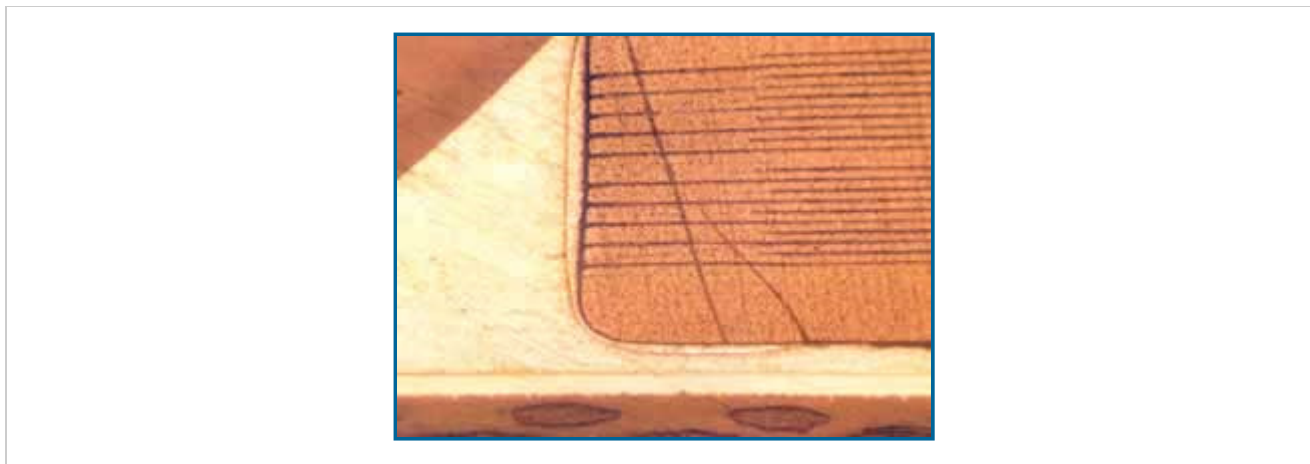
### Bending-induced cracks in an MLC

Cracks which are created as a result of board bending typically look quite different from thermally-induced cracks, being contained within the terminated area, as shown in Figure 4, running from the edge of the termination towards the end face of the chip.

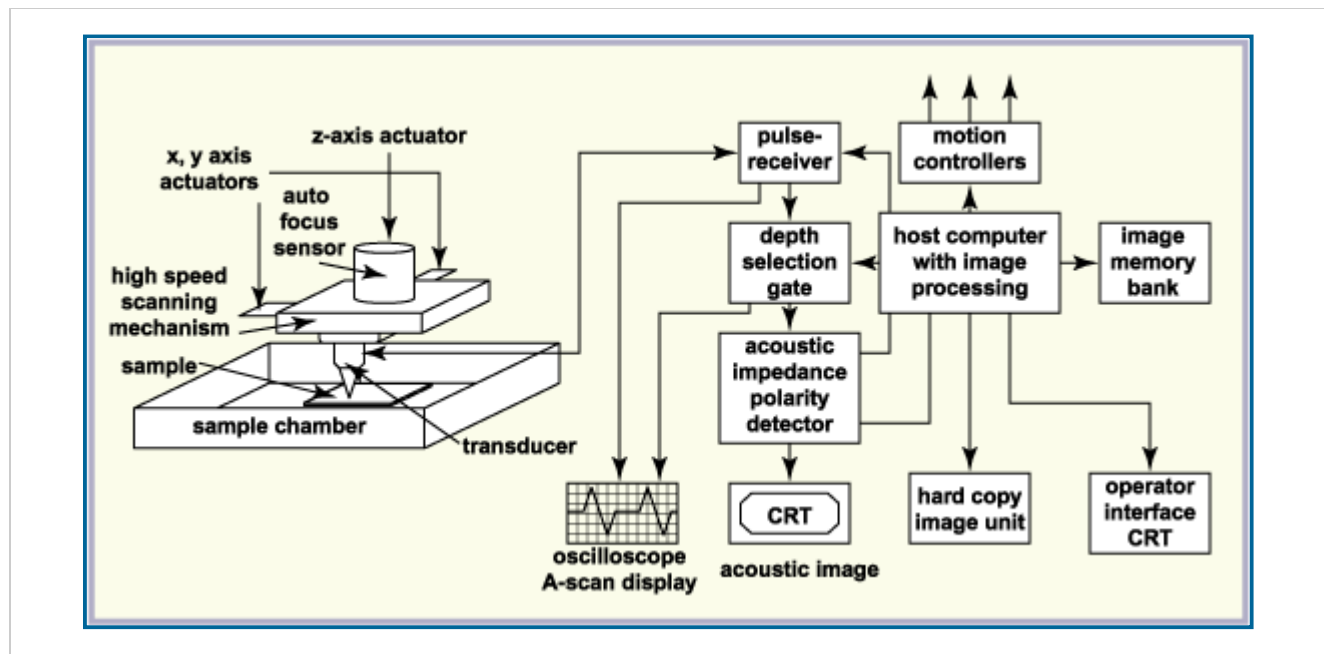
**Figure 5: Schematic of C-SAM principle**

An alternative (and non-destructive) method is scanning acoustic microscopy (SAM), which uses an ultrasonic transducer, typically operating at 10MHz to 100MHz, with the component immersed in fluid (usually water) to couple it to the transducer. The ultrasound travels through the material until it reaches interfaces or discontinuities, which reflect some of the energy.

- **reflection mode**, where sound reflected from the sample gives a high resolution image of the surface and near surface
- **transmission mode**, which creates contrast between areas of different density and signal attenuation, looking at the whole thickness of the sample
- **C mode** (Figure 5), designed for moderate penetration, where ultrasonic energy is focused at an appropriate plane within the sample, and the phase of the reflected wave indicates the density of the material through which it has passed.

SAM can produce direct images of defects within a sample, such as discontinuities, voids and inclusions. The technique has a broader range of application than X ray radiography, because it is not limited to materials of high atomic weight.

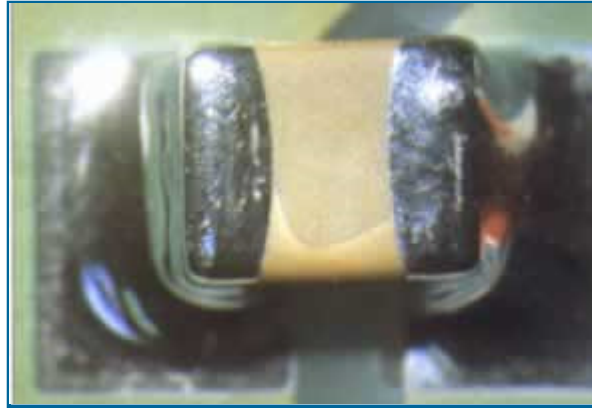
### Capacitor cracking due to placement damage

- Over-pressure and/or nozzle over-travel during placement cycle: few placement machines have any direct control of the actual placement pressure
- Board sag during wave or reflow soldering, caused by poor support, followed by a subsequent straightening process (such as printing, in-circuit test or box build)

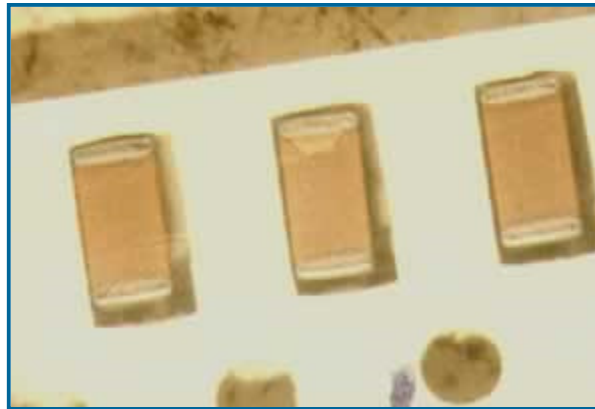
### Capacitor cracked before mounting

When investigating cracking problems, it must be remembered that cracking may occur at an early stage, but only be exposed by the mechanical and temperature stresses of a later assembly process. In the past, components have even been found to be damaged before removal from their packaging!

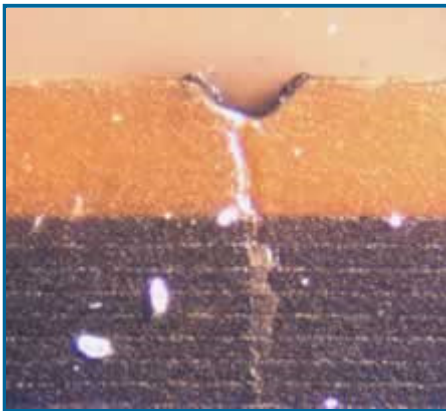
### Capacitor damage due to excessive laser marking

When you investigate failures, you should always expect the unexpected. Chip ceramic capacitors are usually unmarked, because of the practical problems of doing this. However, some end customers, particularly in the automotive industry, prefer capacitors to be marked, so that they can have visual assurance that the correct component has been fitted. Given the small dimensions of the components, the most obvious method for marking is to use a laser to 'write' on the ceramic surface. Provided that this is carried out with appropriate power levels, this coding is effective and not damaging. However, if too high a power setting is chosen, then the laser coding can generate cracking down into the sensitive dielectric area. As we explained earlier, cracks are always bad news!
